EPSON PRODUCT SUPPORT BULLETIN

Date:	2/2/2004	Originator:	JD
PSB #:	PSB.2004.02.008	Authorization:	Kas/DS
Reference:	TE03-379 Rev. A	Total Pages:	2
Product(s):	Perfection 1670/2400/3170/3200 Series Scanners & Stylus CX3200/5200/5400/6400/Stylus Photo RX500 All-in-One Products		
Subject:	Smart Panel Compatibility on Mac OS 10.3

Date:	2/2/2004	Originator:	RY
PSB #:	PSB.2004.02.004	Authorization:	Kps/DS
Reference:	TE03-389 Rev. A	Total Pages:	2
Product(s):	Expression 1600/1680/1640XL Series Scanners; Perfection 610/640/1200/1240/1250/1260/1640/1650/1660/1670/2400/2450/3170/3200 Series Scanners; Stylus CX5200/CX3200/CX5400 All-in-One Products		
Subject:	EPSON Scan TWAIN Ver. 1.28 for Mac OS 10.2 to 10.3

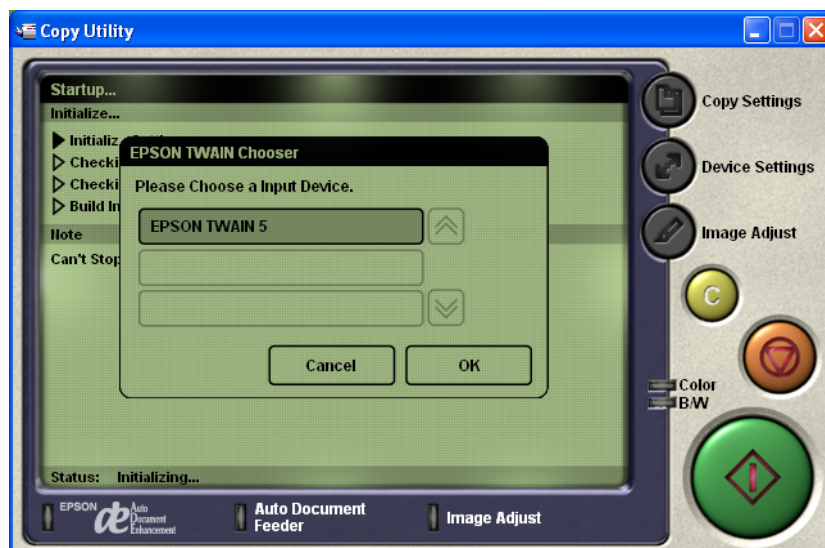
If you are using Copy from EPSON Smart Panel 2.5/2.6 or you installed the Copy utility 2.00A patch for Smart Panel 2.0A/1.0.xA, you may find that the program produces copies with a light gray/blue/pink background.

This is because when printing to non-EPSON printers with the Copy utility, the Automatic Document Enhancement feature is turned off by default.

To remove the background, you must enable Automatic Document Enhancement. To turn on this feature, launch the Copy applet by double-clicking on its icon. Select Epson TWAIN 5 at the following window and click "OK".
