EPSON PRODUCT SUPPORT BULLETIN

Date: 03/18/2004
PSB #: PSB.2004.04.004
Reference: N/A
Product(s): Stylus Photo 2200/R300/R300M/R800/RX500/RX600, and the Stylus CX6400
Subject: Windows XP warning message for HI-SPEED USB (USB 2.0) Devices

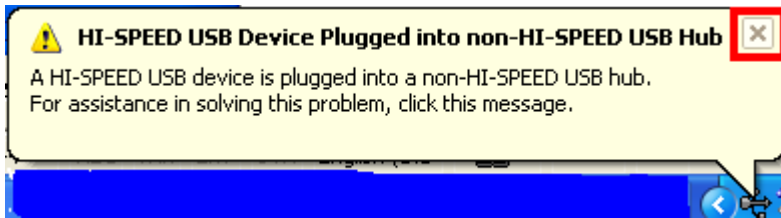
This bulletin was created to inform you of a Windows XP warning message that comes up when an EPSON HI-SPEED USB (USB 2.0) Printer or All-in-One device is connected to a non-HI-SPEED USB (USB 1.1) Port. The message is only an indication that Windows XP recognizes a USB 2.0 device is connected to a USB 1.1 port. This warning message appears the first time the printer is connected to the computer, and every time the printer is powered on. It is NOT an error message. The message cannot be disabled, but you can close it by clicking on the “X” as shown in the red box below.

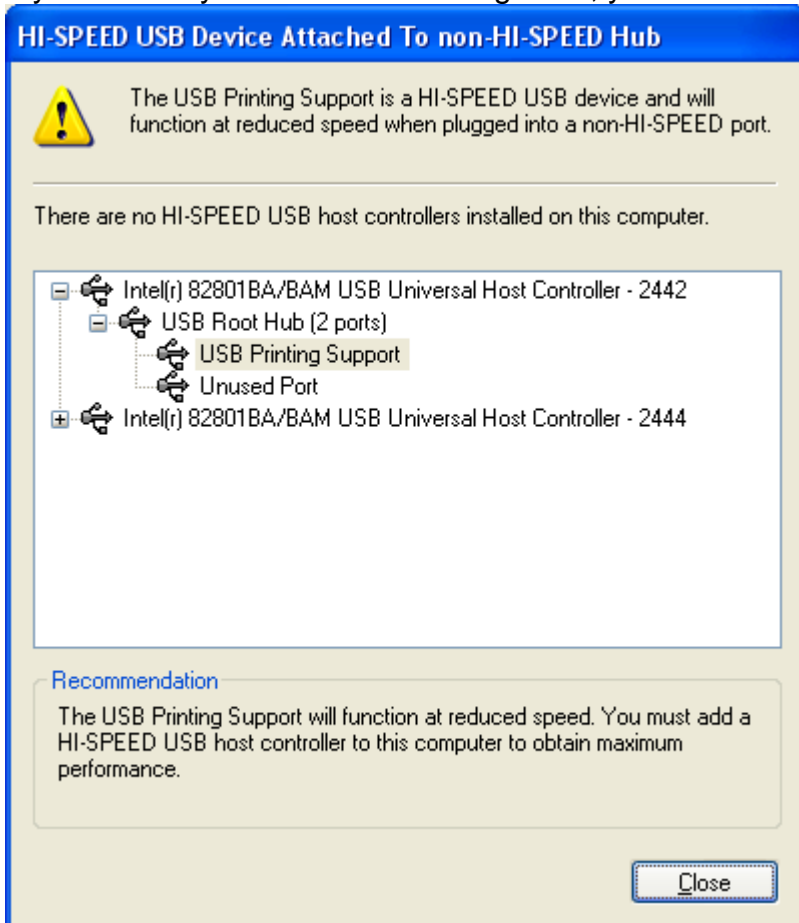
If you click anywhere in the message box, you will see the screen below:

Click on the “Close” button to close the window.
