EPSON PRODUCT SUPPORT BULLETIN

Date:	8/30/2007	Originator:	DS
PSB #:	PSB.2007.08.001	Authorization:	Kps
Reference:	N/A	Total Pages:	1
Product(s):	Epson Projectors with an HD-15 VGA Analog/Component Input		
Subject:	Elmo HV-110XG Document Camera and Projector Compatibility

Date:	10/08/2004	Originator:	DS
PSB #:	PSB.2004.10.002	Authorization:	Kps
Reference:	TI 04-46e Rev. A	Total Pages:	14
Product(s):	EMP NS Connection, EMP Network Manager, EMP Monitor, EMP Multi Screen Adjustment, Cinema Color Editor, VCOM Driver		
Subject:	Evaluation results of Epson Projector PC applications tested in Windows XP with SP2.

Date:	10/25/2002	Originator:	TC
PSB #:	PSB.2002.10.003	Authorization:	Kps
Reference:	TI02-35e Rev. A	Total Pages:	1
Product(s):	PowerLite 720c / 730c		
Subject:	No sound heard when using a resistive attenuator audio cable.

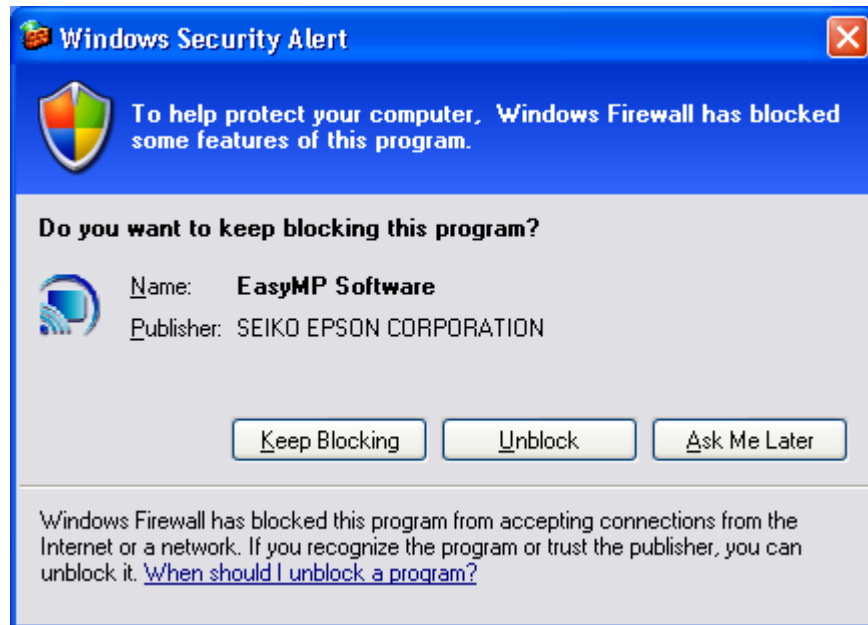
[EMP NS Connection]

Security alert screen (EMP NS Connection)

- **PC applications will work normally on Windows XP with SP2 if the “Unblock Item” is selected when the security alert screen is shown.**

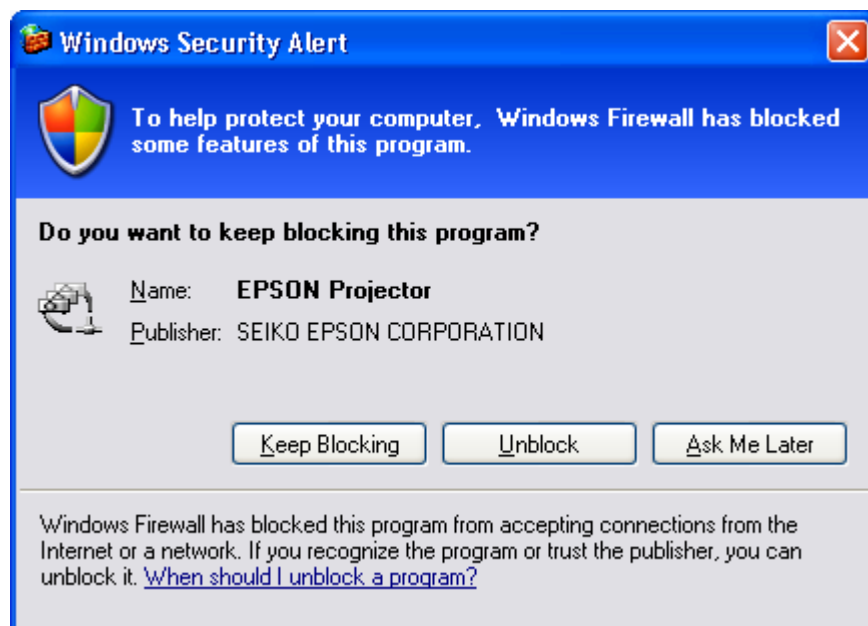
[EMP Network Manager]

Security alert screen (EMP Network Manager)

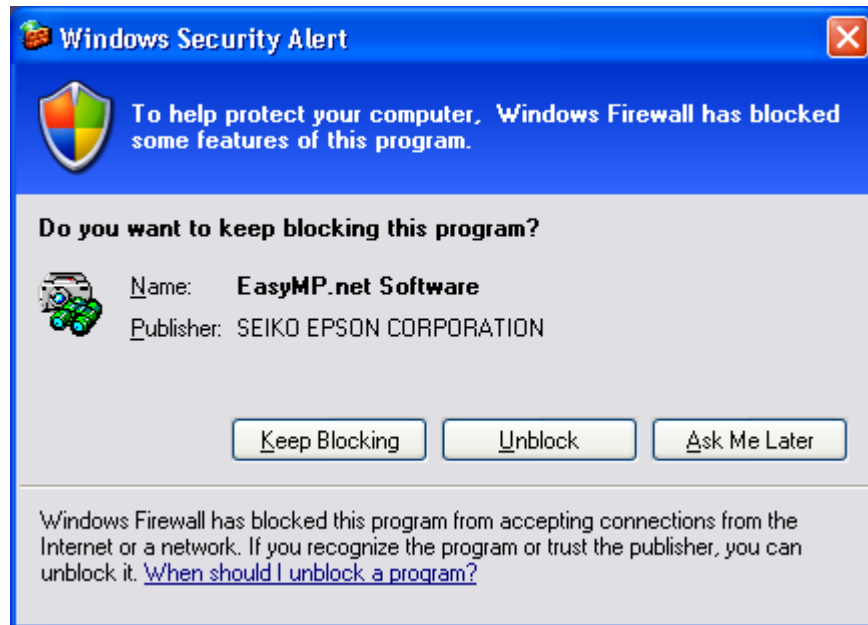
[EMP Monitor]

Security alert screen (EMP Monitor)

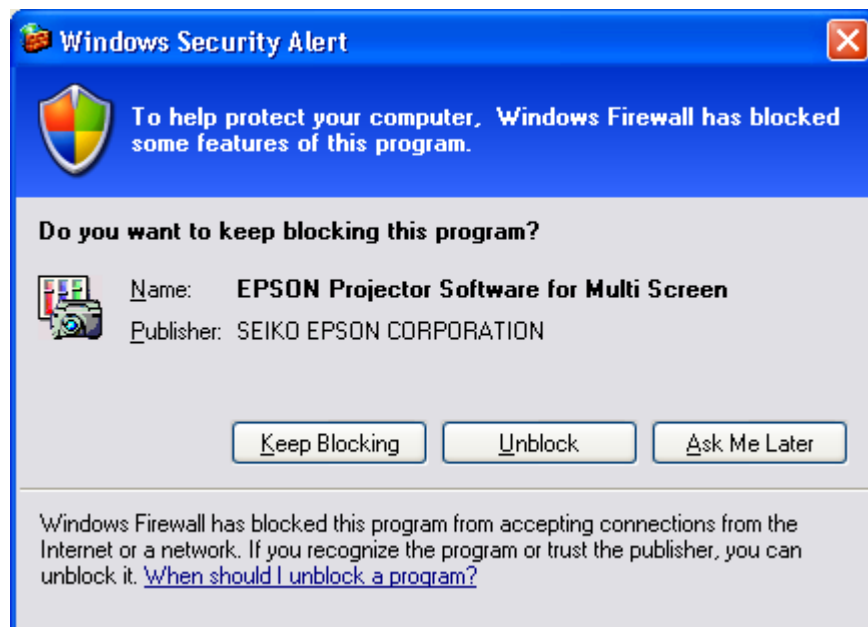
[EMP Multi Screen Adjustment]

Security alert screen (EMP Multi Screen Adjustment)

The Security Alert screen for **EMP Multi Screen Adjustment** is shown after clicking the **Auto** button of **Network** or clicking the **Add** button after entering an IP address in the **IP Address** box.

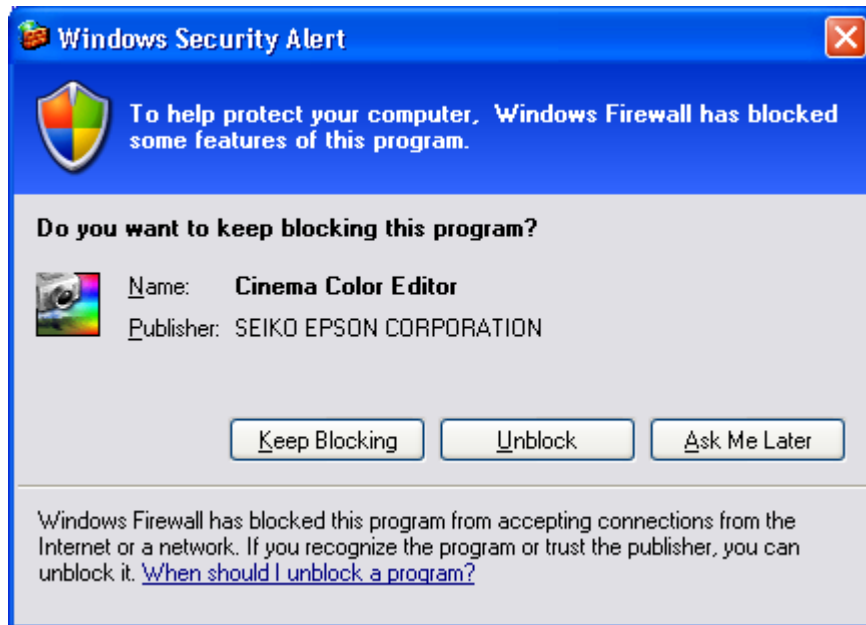
[Cinema Color Editor]

Security alert screen (Cinema Color Editor)

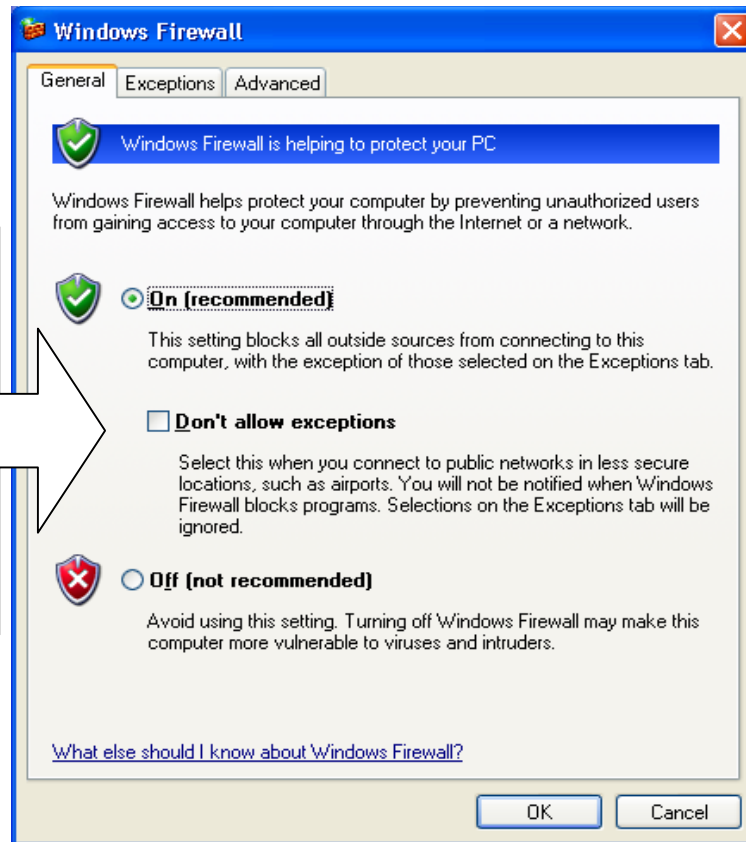
Windows Firewall screen

[Caution]
In case the check box
for **Don't allow
exceptions**
is checked (this box is
not checked at the
initial setting), a
network port for
software is not
unblocked even though
the software is checked
on **Exceptions**.
Make sure this option is
not selected.

- b.) Select and start **Windows Firewall**

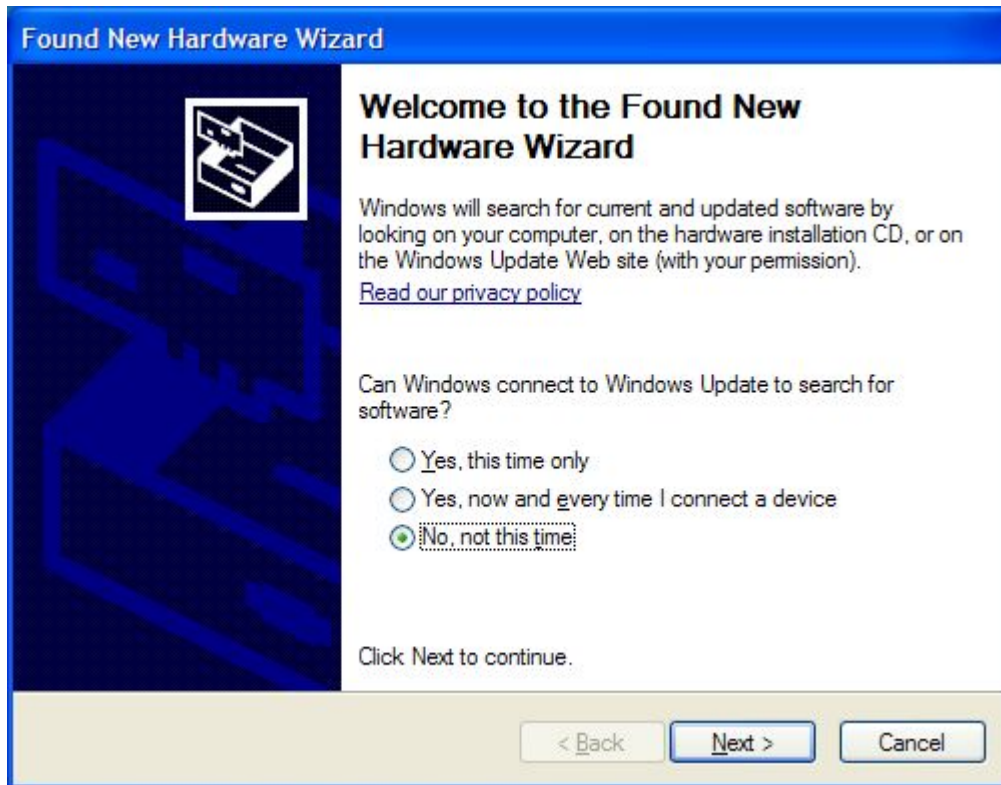
The following message is shown after the VCOM driver is installed on your PC. Select “No, not this time” item and continue the Plug&Play of the device.
