# EPSON PRODUCT SUPPORT BULLETIN

<b>Date:</b>	04/20/2009	<b>Originator:</b>	JAM
<b>PSB #:</b>	PSB.2009.06.001	<b>Authorization:</b>	<i>Kas</i>
<b>Reference:</b>	TI 09-05e Rev. A/B	<b>Total Pages:</b>	5
<b>Product(s):</b>	PowerLite 735c / Cinema 500 / 737c / 745c / 755c / 765c / 830p / 835p / 1705c / 1715c / 6100i / 6110i / 7800p / 7850p / 7900NL / 8300i / 8300i with EasyMP.net module / 9300NL / 1815p / 1825 / 822p / 83c / 822+ / 83+ / G5000 / Pro G5150 / Pro G5350 / Pro G5200W / 1725 / 1735W / 400W / 410W / 84 / 85 / 825 / 826W PowerLite 61p / 81p / 82c / 821p / 1810 / 260d (Latin America) / 280d (Latin America) with TCP/IP to Serial converter		
<b>Subject:</b>	Release of EMP Monitor for Windows version 4.30

This bulletin was created to inform you of the release of the new version 4.30 of the Epson EMP Monitor software utility.

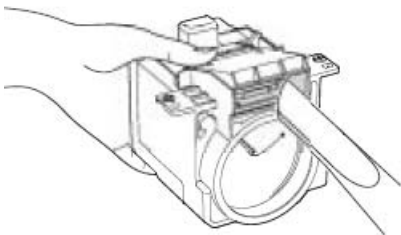
- 1) Wire mesh filter (inside lamp housing shutter):

The PowerLite 8300 and 9300 series projectors have five (5) filters that must be cleaned on a regular basis. Cleaning the filters is critical to maintaining proper airflow inside the projector and reducing possible overheating issues. Incomplete or infrequent filter-cleaning maintenance can cause one or more filters to accumulate excessive dust over time. This can inhibit proper airflow so that the projector begins to overheat during operation and eventually shut down. The next section provides information on the location of the filters on the projector, cleaning instructions and recommended maintenance schedules.

Hold shutter open and use a computer vacuum to remove dust.

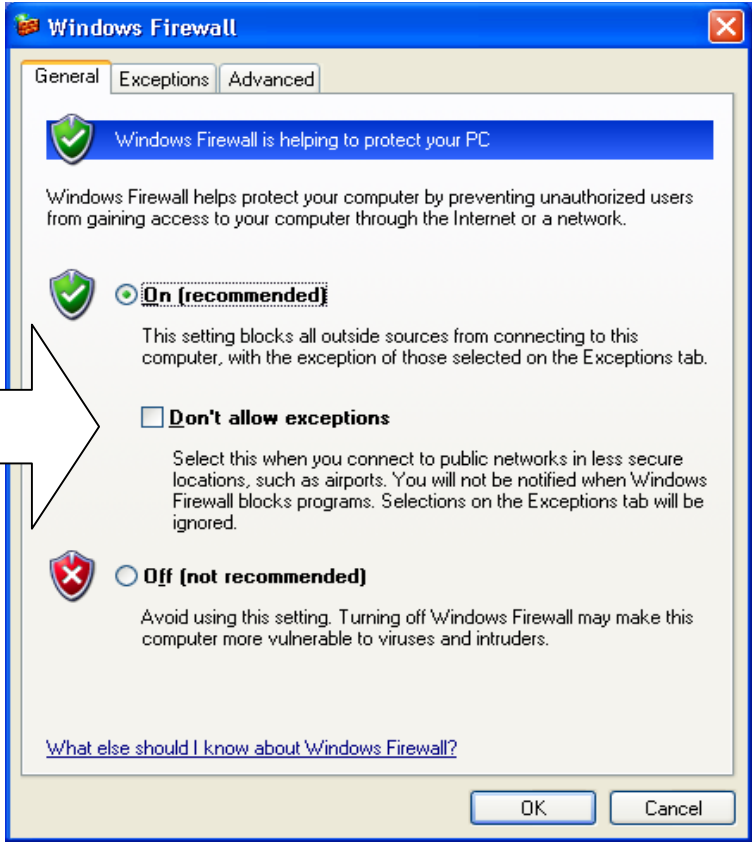
Windows Firewall screen

[Caution]  
In case the check box for **Don't allow exceptions** is checked (this box is not checked at the initial setting), a network port for software is not unblocked even though the software is checked on **Exceptions**. Make sure this option is not selected.

- b.) Select and start **Windows Firewall**
