# Pro-L25000UNL

## Firmware v2.14 Release notes

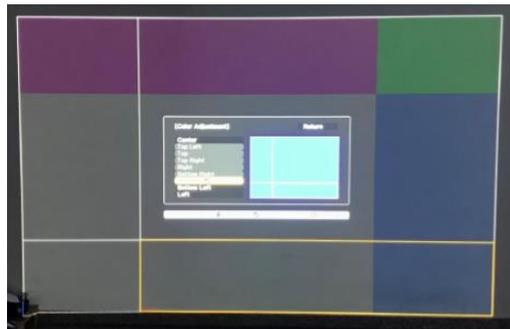
e.g.) When the installation before "Factory reset" is "Front/Ceiling"

10. When the "Factory reset" is executed on the unit used with installation angle other than "Front", following symptoms occur after the "Factory reset"

- (1) Black level adjustment area which is set before executing "Factory reset" stays in the same position
