EPSON RC+ 4.1.1 SP1 Release Notes

February 28, 2006

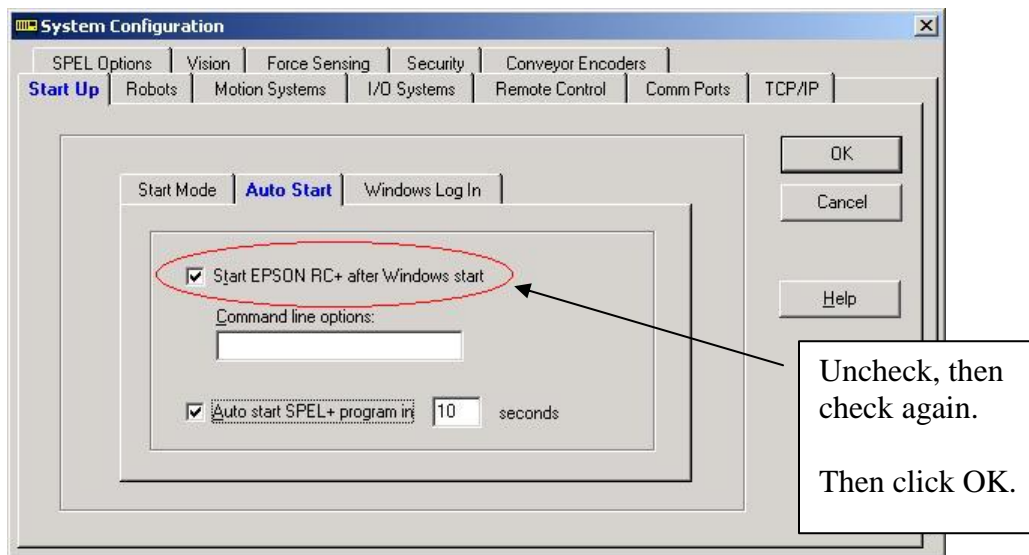
Auto start does not work after upgrading from 3.x versions

If RC+ was configured to auto start after Windows start, it will no longer start up automatically after upgrading to a 4.x version. This is easily fixed.

1. Run EPSON RC+. Click **Change Startup Mode**. Select **Program / Debug**, then click **OK**.
2. Select Setup->System Configuration. On the **Start Up** tab, click the **Auto Start** tab. Uncheck **Start EPSON RC+ after Windows start**. Then check it again. Click **OK**.
