PROCEDURE FOR UPDATING TM-T20II mPOS FIRMWARE TO v1.02AIP

REASON FOR THIS UPDATE

C31CD52A9961 T20II (mPOS with UB-R04) C31CD52A9951 T20II (mPOS with UB-R04)

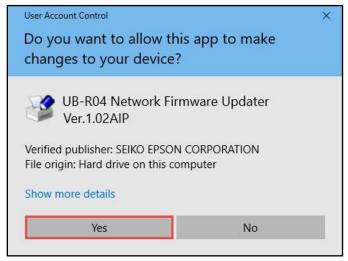
Fig. 1

- 2. Double-click the "UB-R04 Network Firmware Updater Ver.1.02AIP.exe" file.
- 3. Depending on your computer configuration, the following window may appear (Fig.1). Select "Yes" as highlighted in red below.

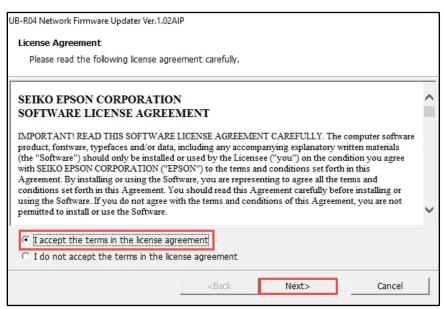
Fig. 2

4. A License Agreement window will appear (Fig. 2). Carefully review the License Agreement and select "I accept the terms in the license agreement", then click "Next" as highlighted in red below.

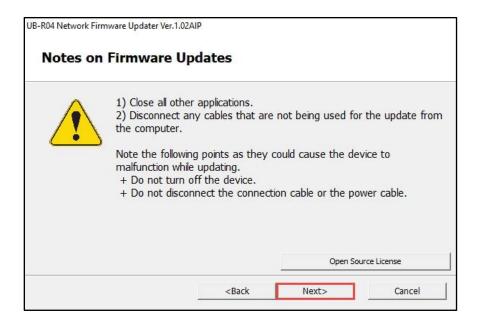
Fig. 3

5. In the next window (Fig.3), review the information and click "Next" (highlighted in red below) when ready.

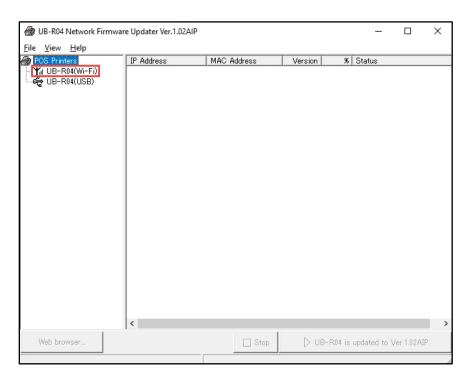
<u>Fig. 4</u>

6. The following window will appear (Fig.4). Select the UB-R04(Wi-Fi) option (highlighted in red below) or the UB-R04(USB). If no printers appear in this window, turn off your firewall, and antivirus software, then refresh the page by pressing the F5 key on your keyboard. Wi-Fi is used in this example, but the steps are the same for a USB connection.

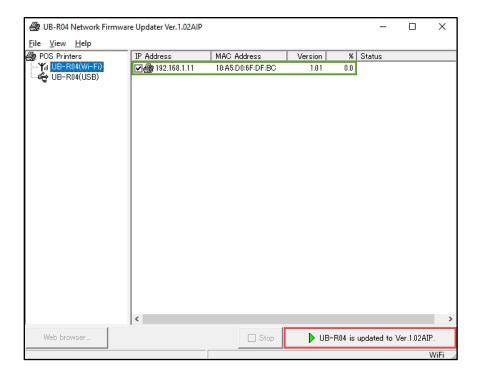
Fig. 5

7. Once one or more printers appear, check the box next to the printers you want to update (example of a selected printer is shown in Fig.5, highlighted in green). Click the "UB-R04 is updated to Ver.1.02AIP." button (highlighted in red below).

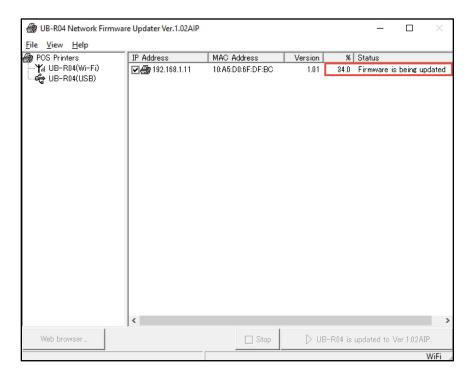
Fig. 7

9. After a few seconds, the window will look like the one in Fig.7 below. The percentage column will change, and status will read "Firmware Data Sending".

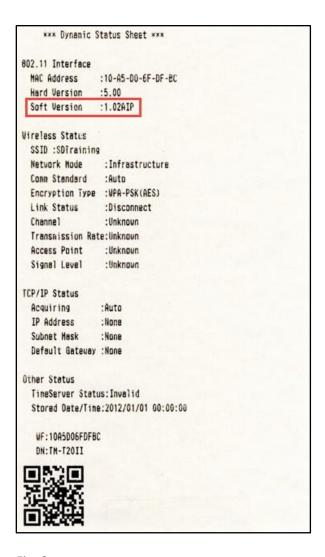
Fig. 9

11. When the update is finished, the printer will print out the sheet shown in Fig.9. Confirm the "Soft Version" on the print out (highlighted in red below). It should read "01.02AIP". If you've selected multiple printers in step 7 above, the next selected printer will start updating automatically.
